Optical NDT supporting the restoration of a marble sculpture on the facade of the Gesù Nuovo church in Naples

Abstract – The study focuses on an angel marble sculpture, placed on the central portal of the Gesù Nuovo church in Naples. The non-destructive and non-invasive optical techniques used were Active Thermography (AT) and 3D scanning. The measurements were carried out before and after the restoration of the marble sculpture, consisting in the consolidation of some disintegrated areas and in the removal of both black crusts and biodeteriogens, present in various areas of the sculpture.

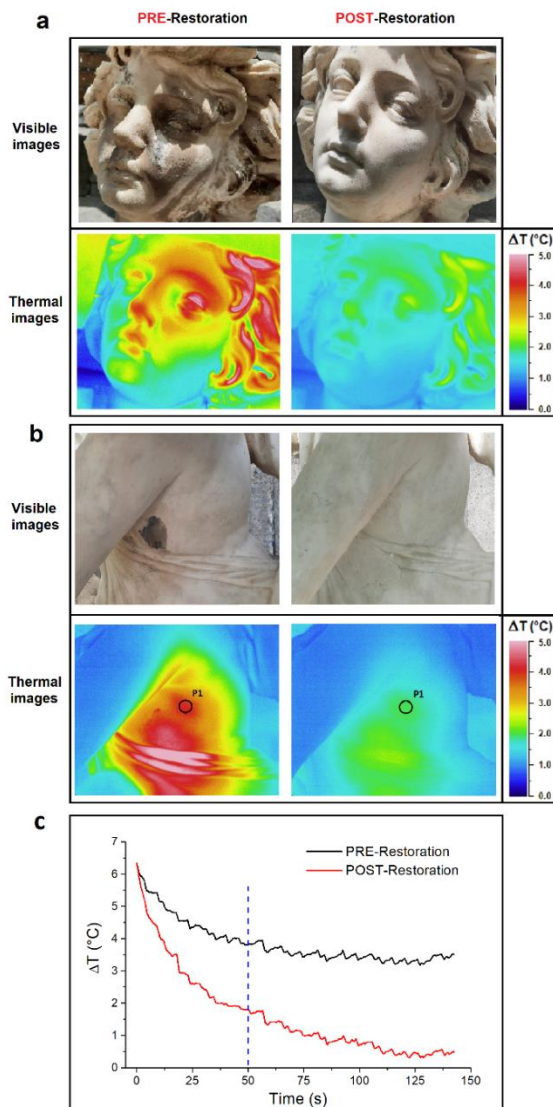
The AT analysis was performed on the marble sculpture investigated before and after the planned restoration work. The information obtained in PRE-phase allowed the detection of structural anomalies of various kinds and especially the areas of the surface most affected by crusts and patinas. This information allowed to carry out a more targeted and specific action in the restoration work and the results obtained were then examined by comparing the thermal data achieved both before and after restoration. As an example, Figure 1 shows visible and thermal images achieved before (PRE) and after (POST) restoration of two analyzed areas of the sculpture: face (1a) and body (1b). The thermal images showed refer to the induced thermal gap ΔT measured 50 seconds after the heating and achieved by subtracting the thermal frames $T(50)-T(0)$ extrapolated from the recorded sequences $T(t)$.

As clearly visible, in both cases the ΔT measured in different areas of the PRE thermal images are higher than those obtained in the POST.

In the graph in Figure 1c are reported the temporal thermal trend of the area P1 (indicated in the thermal images 1b),

extrapolated in the PRE and POST thermal sequences recorded. As can be seen, in the PRE-trend (black line), recovery is slower than in the POST-trend (red line) due to the presence of crusts which were eliminated during the restoration work.

The presence of crusts and patinas on the surface changes its reflectivity and roughness and probably increases the average local specific heat, this leads to greater overheating of these areas during the daily cycle and to a slowdown of the heat dissipation process, increasing their heat recovery times and reducing their capacity of acclimatization with the external environment. Basically, the presence of such crusts on the surface of the sculpture can lead over time to serious problems of degradation and deterioration due to the greater thermal stresses affecting these areas.

Fig. 1 Example of AT analysis performed on the marble sculpture investigated. Thermal and visible images acquired before (PRE) and after (POST) the restoration

work of two areas of the sculpture: (a) face and (b) body. (c) PRE (black line) and POST (red line) temporal thermal trend of the area P1 indicated in the thermal images in (b). The dashed blue line refer to the time $t=50$ s in which the ΔT in the thermal images in (a) and in (b) were calculated.

The used methodology aims at achieving a completely sustainable restoration, non-toxic for the operator, and with low environmental impact, of the sculpture of the angel on the right of the central portal of the Church of the Gesù Nuovo. The sculpture exhibited widespread surface erosion, with some areas experiencing disintegration, particularly on the right foot's big toe and the entire right hand. There was a pervasive biological attack caused by Hyphomycete fungi, specifically *Aspergillus* genus, as well as gram-positive heterotrophic bacteria, *Clostridium* sp., embedded on the stone surface due to the presence of guano. Various deposits remained on the surface, ranging from loose ones to typical black dendritic crusts that caused significant thermal stress on the surface. The restoration procedure employs various non-invasive and minimally invasive analysis techniques: preliminary operations of dusting and a first surface rinse were carried out; then, the pre-consolidation of the disintegrated areas was performed using a 30% aqueous-based nanosilica, which, in tests with nanocalce, yielded better penetration and consolidating action results; finally, the cleaning phase began in order to remove the carbonaceous deposits. Thicker black crusts were first thinned using a micro-drill, and then a gel of agar powder at 1-2% concentration mixed with water and various percentages of sodium bicarbonate (primarily 10-30-70%) was applied. The gel was applied in a fluid manner to create a thermal shock on the crust and facilitate subsequent removal, which was done mechanically with a scalpel. Finally, a natural antifungal, based on essential oils, was tested and yielded excellent results compared to traditional biocides. Once the cleaning was complete, consolidation operations were carried out, including some fillings to provide more coherence to the area. After all the fillings were completed, the entire surface was impregnated with lime water to restore compactness, and a thin layer of microcrystalline hot wax was applied as a protective coating.

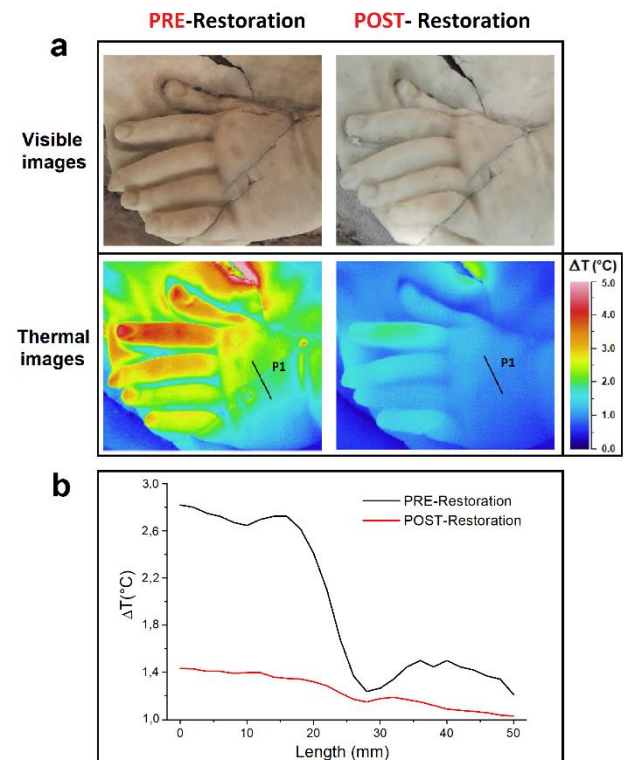
Figure 2 shows the AT analysis performed on the hand of the sculpture. As can be seen, in the PRE thermal image, the fracture on the hand delimits two areas with very different thermal responses. This is presumably due to rainwater which, entering through the cracks, accumulates in the cavity under the hand, increasing its thermal inertia and slowing down the natural heat dissipation process. However, the comparison between the PRE and POST thermal images show how this discrepancy in the thermal behavior of the two parts of the hand was greatly attenuated after the local filling carried out during the restoration works.

Fig. 2 AT analysis of the hand of the marble sculpture investigated: a) thermal and visible images acquired before (PRE) and after (POST) the restoration work, b) PRE (black line) and POST (red line) spatial trend of the temperature referred to the P1 lines indicated in the PRE and POST thermal images.

In Figure 2c are reported the spatial trend of the temperature referred to the P1 lines indicated in the thermal images. The spatial trends measured PRE (black

line) and POST (red line) also confirm, from a quantitative point of view, how the two parts of the hand show a much more similar thermal response after the restoration works.

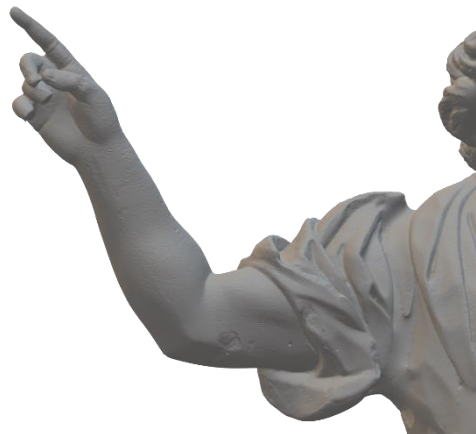
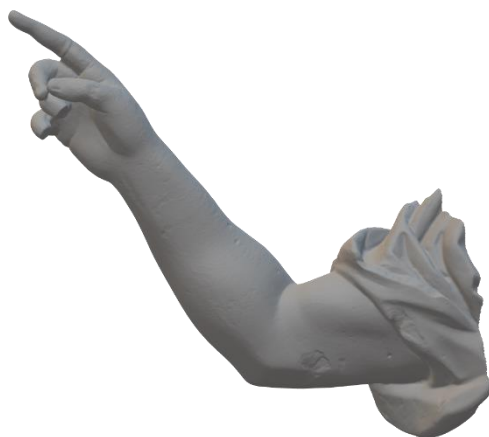
As to the 3D scanning measurements, figure 3 shows the 3D geometry of the sculpture before (PRE) (fig.3a) and after (POST) (fig. 3b) the restoration work.

Fig. 3 3D scanning measurement of the arm of the marble sculpture investigated (a) before and (b) after the restoration work.

We focus our attention only on a part of the sculpture, i.e. the angel arm, because, due to the presence of the scaffolding, it was not possible to scan the entire statue. It is clear that the restoration work has not caused structural changes, but only a decrease in the surface roughness in some parts of the marble sculpture. In fact, as shown in Fig. 4, the marble surface after the restoration work appears more compact and smooth.

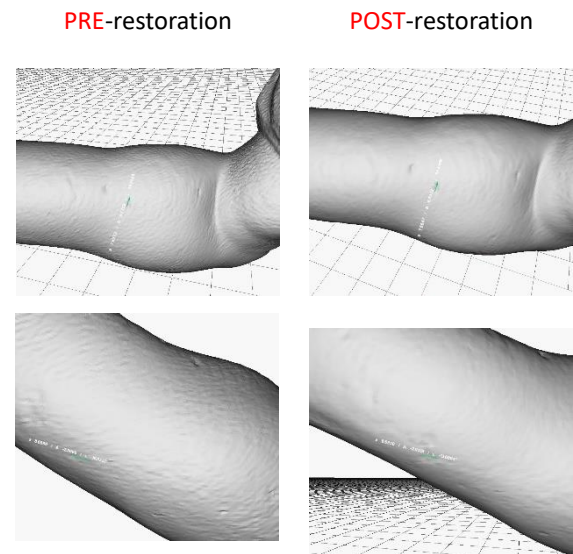
Fig. 4 Details of the 3D scanned sculpture arm, before (left) and after (right) the restoration work, showing surface roughness' change
