From the context knowledge to Assessment of the Architectural Heritage decay: the case of Santa Maria di Vezzolano rectory (AT)

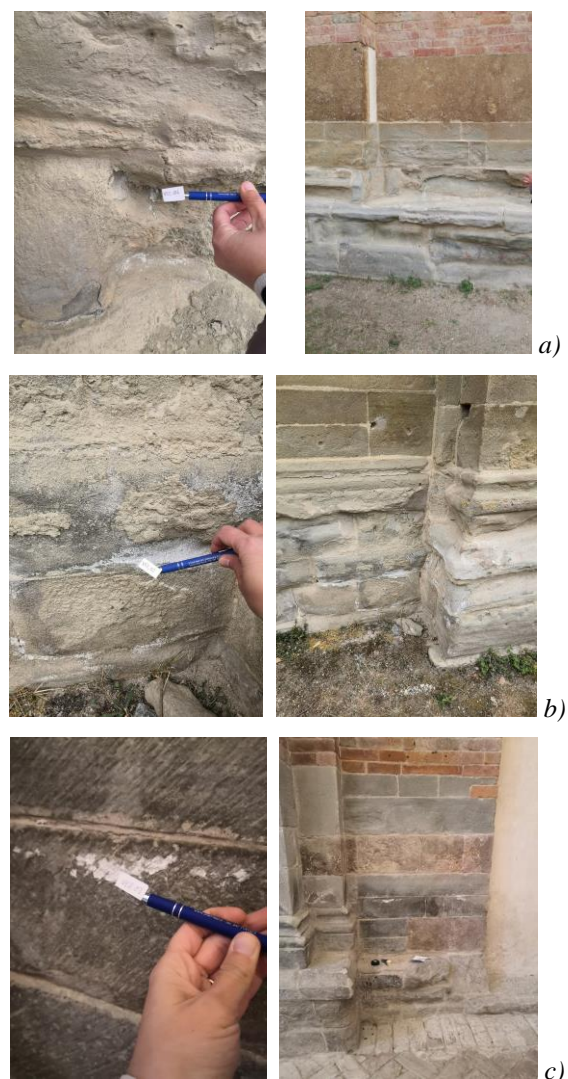
The Ion chromatography analysis (IC) provided a quantitative characterization of the different samples analyzed. In particular, degradation products namely salt efflorescence, widely visible in the lower portion of the façade were taken at three different heights of the investigated façade (Table 1; Fig. 2).

Fig. 2. Sampling areas of the three saline efflorescence samples analysed by ion chromatography: a) VeZ_01; b) VeZ_02; c) VeZ_03.

The efflorescence and sub-efflorescence salts formation, characterized by ion chromatography analyzes (in order of abundance sulphates, chlorides and nitrates of calcium, magnesium, sodium and potassium), is therefore to be associated with capillary rising phenomena within about 1 meter from the floor level.

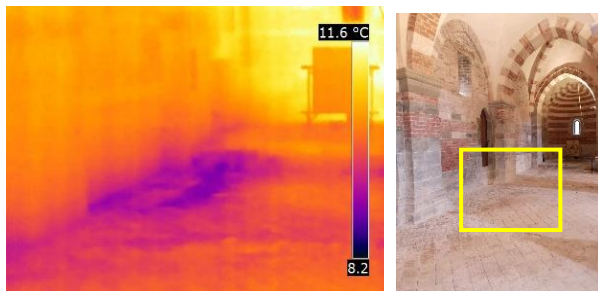
3. that neither the vault nor the walls are currently affected by water infiltration from the roofing system; slight capillary rising fronts can be observed along the lower part of the internal wall of the lateral nave;
4. rising damp along part of the side nave flooring, along the portion closest to the apse area (Fig. 5).

Fig. 5. IRT and localisation of the investigated area: The lower part of the internal masonry and the flooring show the presence of rising damp.

The accumulation of water present in the subsoil found by the geoelectrical analysis on the inspected portion of the perimeter can be correlated to the evidence of capillary rise revealed in thermography along the pavement and the lower portion of the internal walls. The total absence of rain [5] in the months prior to the investigation period (April 2022) and the lack of other thermal anomalies associated with the presence of rainwater further confirm the correlation between the presence of water in the subsoil and the degradation which has induced evident exfoliation, detachments and loss of material of the sandstone blocks constituting the lower part of the elevation directly in contact with the ground.

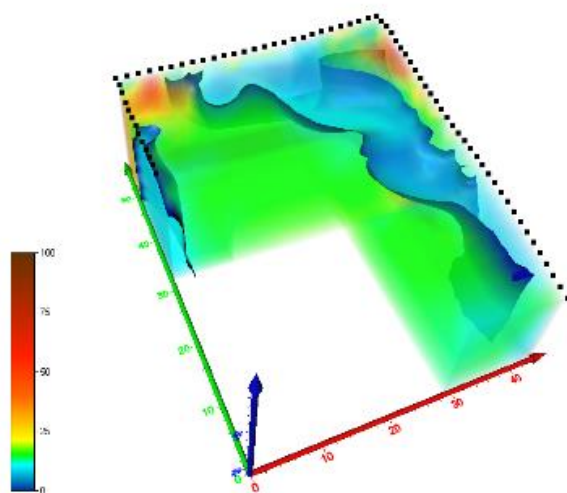
The geoelectrical investigation found the presence of underground water, providing useful elements for understanding the evident and continuous process of degradation involving the sandstone ashlar of the elevation as well as the other perimeter walls and which caused the ineffectiveness of the previous consolidating treatments (Fig. 6).

Fig. 6. 3D rendering of the resistivity data

The inverse model of electrical resistivity showed, in fact, the presence of two lines of water flow which run

following the two natural slopes of the site and induce an accumulation of underground water along the road which flanks the side nave up to the main elevation and along the slope that flanks the apse area.
