Decay assessment approach of building stones from cultural heritage in freshwater reservoirs

Ada Sáez*¹, Natalia Pérez-Ema¹, Mónica Álvarez de Buergo¹

town of The Royal Site of La Isabela, located in the Buendía reservoir in the province of Guadalajara.

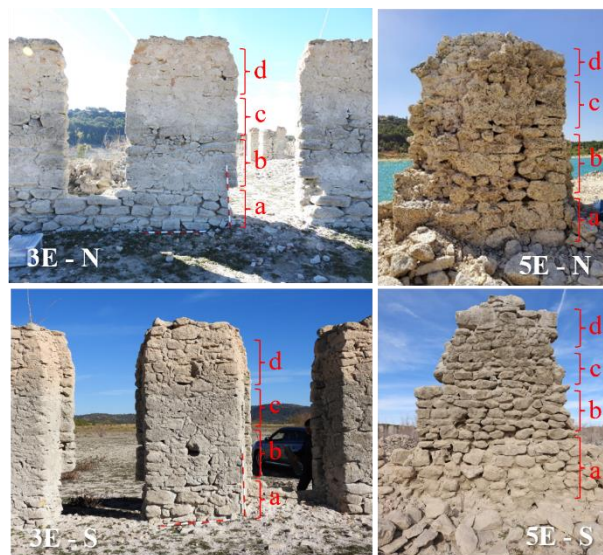
Fig. 3. On the left, the studied wall in the farthest part from the reservoir (3E - N and S façades). On the right, the wall from the closest part to the shore (5E - N and S façades). Height sections are marked in red (a, b, c, d). All pictures were taken in the dry season.

- Loss of construction material, mainly in the crowns and sides of the walls (the original openings of the windows and doors), related to the loss of joint mortars and the movement of water during the phases of total submersion, which causes the displacement of elements (Fig. 3).

- Cracks and fractures, both across the sandstone ashlars and vertically along the walls (Fig. 3).

- Severe granular disaggregation and rounding of the sandstone ashlars (Fig. 3 and 4. A).

There is a noticeable color zoning by height within each façade that can be appreciated in Fig. 3. The walls furthest from the shore, which tend to spend more time semi-submerged and never fully submerged, there is greater contrast in color between heights, especially in the crowning. However, in the walls that spend more time submerged, the lower areas are the most saturated in color, likely due to the mud crust that deposits and the longer

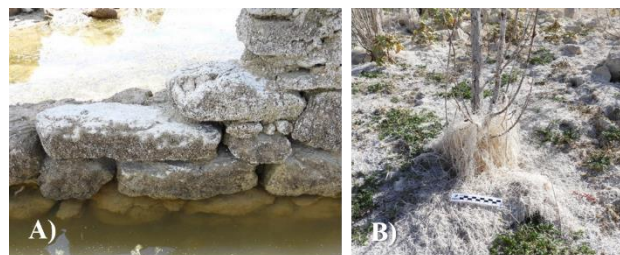
Sulfated water and the dissolution of the walls' gypsum rendering is likely to be the reason why most efflorescences are sulfate salts. Another interesting phenomenon is that during the wet season, a common charophyte algae grows and spreads all over the surface of La Isabela's terrain. In the dry season, these algae dry out and tend to calcify, leaving only a fragile hollow structure that turns into dust and covers the site (Fig. 4B). Therefore, most of the crusts present a high content of calcite along with the sulfate salts.

- Formation of heavy crusts of salt efflorescence and mud (Fig. 4. A).

Fig. 4. A) Formation of salt efflorescence on the top of sandstone ashlars during the emersion period. Mud crust and bio-colonization can also be observed. B) Calcified algae during the dry season.

- Biodeterioration, lacustrine vegetation, and algae growing on the surface of the walls and inside the structures (Fig. 4).

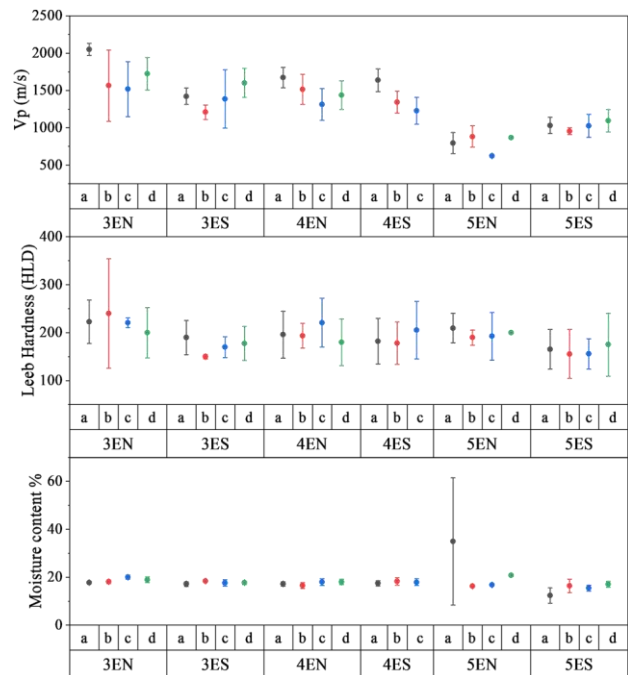
The ultrasound pulse velocity (UPV) results in Fig. 5 show that the walls furthest from the shore and the North-facing façades of each wall mostly obtain higher average values of propagation velocity V_p (m/s) than the walls closer to the reservoir and the South-facing façades. The maximum value is obtained from the North-facing façade of wall 3E with (1715±352) m/s, and the minimum is from the North-facing façade of wall 5E with (762±148) m/s. It is worth noting that the differences between the North and South orientation of each wall are more pronounced the further they are into the reservoir; walls 3E and 4E differ by 18% and 6% respectively between their North and South façades, while wall 5E differs by 31%. These data indicate that, on the one hand, the longer the walls are submerged (like 5E), the lower their average V_p , and therefore, the worse their state of preservation in terms of internal material cohesion. Furthermore, wall 5E is more exposed to the action of water as it is the last line of buildings from La Isabela. Similar to what happens in coastal areas, during low tides, water drags sediments and destabilizes the terrain, which here is predominantly sedimentary and clayey, potentially leading to structural alterations in the walls. On the other hand, orientation

Regarding the variation in height within each façade, the areas with lower average Vp values are the intermediate ones (zone c, followed by b). These are the heights where the water level spends more time throughout a hydrological year, as they are transitional states between cycles of immersion-emersion (1 cycle per year), where the walls are semi-submerged. In the hydrological year 2022/2023 it has been observed that the external walls spent a total of approximately 5 months completely emerging, 7 months semi-submerged, and none submerged. In contrast, the walls deeper into the reservoir spent approximately 4 months completely emerged, 4 months semi-submerged, and 4 submerged. During the time they are semi-submerged, the intermediate level of each wall is subjected to a continuous flow of water, which promotes deterioration through physical, chemical, and biological processes. This favors capillary water rise, disaggregation of stone materials, dissolution of mortar joints, growth of efflorescence, deposition of mud crusts, and biological colonization of plants, insects, and microorganisms, generally in the form of biofilms.

The preliminary results of the Leeb micro-hardness test align with those of UPV, showing a similar trend where the walls furthest from the shore and the North-facing façades of each wall have higher average values. The highest value is found in the North-facing façade of wall 3E (221 ± 59 HLD), while the lowest is in the South-facing façade of wall 5E (163 ± 43 HLD). The differences between the North and South façades of each wall are also similar, with a 22% difference in wall 3E, 6% in wall 4E, and less than 1% in 5E. There is no significant variation in hardness with height within a wall, and no conclusive trends are observed in this aspect.

Moisture content results do not show significant variation between different walls, likely because the measurements were taken during the dry season when temperatures can reach values above 40°C . The maximum value is in the North-facing façade of wall 5E (220 ± 145 a.u.), while the minimum is in the South-facing façade of the same wall (153 ± 27 a.u.). The other walls range between 173 and 187 a.u., with low StD without showing significant differences between North and South orientations. The high value in the North-facing façade of wall 5E is mainly due to the presence of visible efflorescence in some ashlar of the lower area, which can increase capacitance and electrical conductivity.

Fig. 5. Results of onsite measurements of ultrasound Vp (m/s), Leeb hardness (HLD), and moisture content (%). Displayed data are the mean values of each height section within each wall and orientation and error bars are the Standard Deviation.

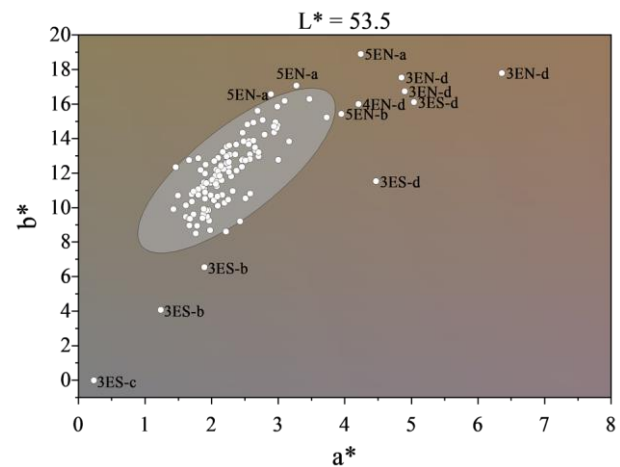
Overall, the results obtained by spectrophotometry show a^* and b^* coordinates in the color space of ochres and browns, being slightly more intense in the North façades than the South façades. L^* and C^* values are also slightly higher in the North façades, indicating greater brightness and color saturation when exposed to less solar radiation. Nevertheless, these values were not that significant, and therefore in Fig. 6 coordinates a^* and b^* are represented for a given average L^* . The color of the graphic is the area in the CIELAB space color that corresponds to our data.

Fig. 6. Representation of color coordinates a^* and b^* for a given average L^* value using the CIELAB 1974 system. The ellipse indicates the centroid of most results which are quite homogeneous. The labeled points are the most scattered ones that indicate significant color changes.
