Diagnostic study and efficiency evaluation of treatments against rising damp and salts crystallization in ornamental stones: the case of the green stone sacristy washbasin in the Church of San Domenico in Cosenza (Calabria, Italy)

Michela Ricca¹, Raffaella Greca¹, Carlo Riente¹, Donatella Barca¹, Luciana Randazzo², Silvestro A. Ruffolo¹, Mauro F. La Russa¹

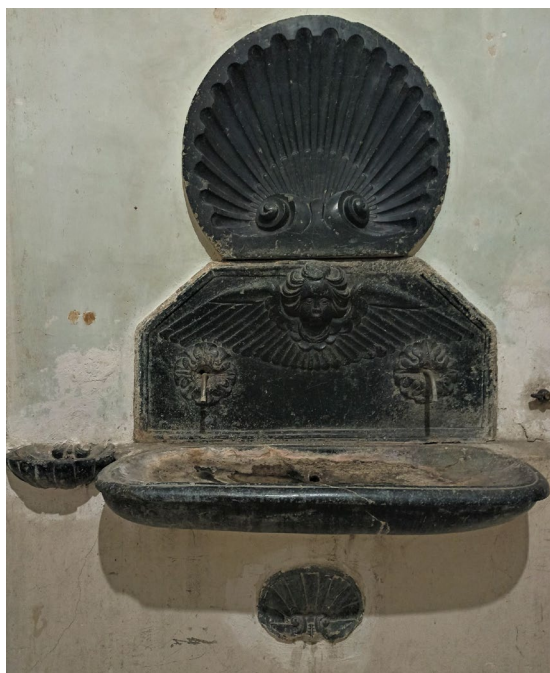
Upon inspection, the stone artifact showed evident decay forms attributable to prolonged exposure to poor environmental factors and conservative conditions. In fact, the conservation state of an artwork is generally determined by multifactor, which may simultaneously occur: decay processes depend both on the environmental conditions to which the artifact/building is exposed (indoor or outdoor conditions) but also on the intrinsic features of the support, such as the different material compositions and the various manufacturing techniques. An accurate diagnostic investigation of both the constitutive material and the alteration and degradation phenomena allowed us to plan a suitable artifact's conservative work. Specifically, an in-depth study was first designed in order to analyze micro-fragments and powders taken from the ancient artifact. Seven samples were subjected to a complementary analytical approach

Fig. 1. Green stone sacristy washbasin in the Church of San Domenico in Cosenza (Calabria, Italy).

The results of the diagnostic investigations made it possible to plan the conservative restoration intervention, starting from the cleaning procedure up to the consolidation of the liturgical object. The artifact was subjected to: a) desalination cycles using ion exchange resins (i.e., strong cation exchange resin), b) cleaning

procedures with tetrasodium EDTA and quaternary ammonium salts, c) the removal of the most tenacious encrustations using mechanical cleaning methods (i.e., scalpel and micromotor). All procedures were carried out after preliminary in situ tests in order to evaluate step by step the effectiveness of the products used and considering the nature of the incrustations/alterations to be removed, without ever damaging the constituent material.

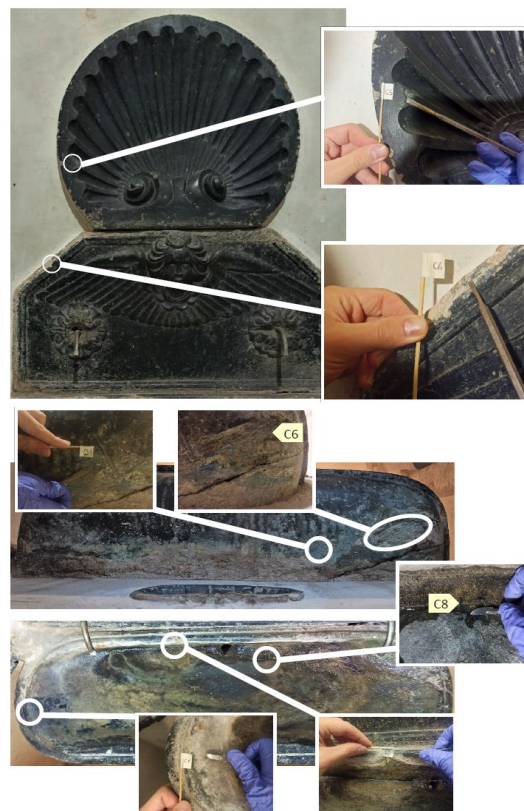
Fig. 2. Sampling points for the sacristy washbasin. Specifically, seven micro-samples were chipped-off from the object, using suitable stainless-steel tools (lancets and small chisels) to establish the composition of the raw materials and the possible presence of alteration products.

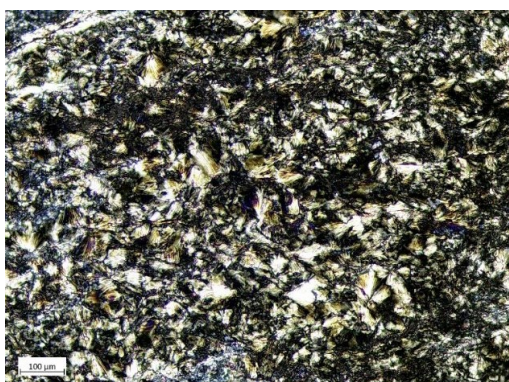
The OM allowed the identification of the C4 and C5 micro-fragments as Chloritoschisti (or Chloritic Schist), a green metamorphic rock essentially composed of minerals of the chlorite group (i.e., phyllosilicates such as chlorite and clinocllore). Epidote and zircon have been identified as accessory minerals. Calcite veins are also present (Figure 3). A patina with a thickness between ~ 50 and 500 μm was also identified on the edge of the section of both samples (Figure 4). It is fairly adhered to the stone substrate, with jagged morphology and the presence of micro-fractures. Given the dominant presence of microcrystalline calcite (micrite), it almost certainly has a carbonate composition; rare oxides can also be observed inside (Figure 4). The OM investigations of samples C4 and C5 were deepened by SEM-EDS. The dominant presence, in both sections investigated, of minute crystals distributed in fibrous-acicular aggregates is further confirmed; the chemical investigation (EDS), ascertains the presence of chlorite and clinocllore, followed by sporadic crystals of titanite and ilmenite. Moving the attention towards the edge of the section confirms the presence of a thin surface patina with a thickness close to 500 μm , already observed using OM. The chemical investigation performed by EDS microanalysis (in terms of major elements) ascertains its carbonate nature. The elemental composition also reveals a minimal presence of sodium, chlorine, and sulfur, with traces of copper.

Fig. 3. Thin section photomicrograph of sample C4.

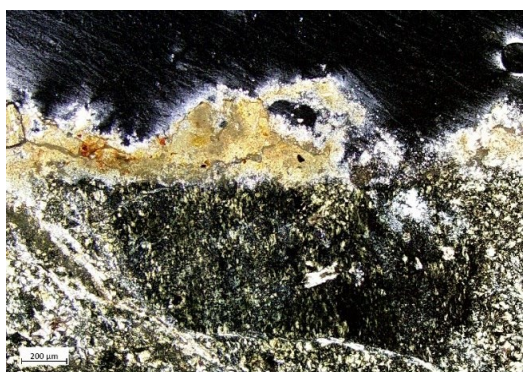
Fig. 4. Thin section photomicrograph of sample C4 with alteration patina.

As regards the state of conservation, inherently to the surface patina present in both samples (i.e., C4 and C5) it can be assumed that: a) the presence of calcium carbonate in the patina is due to traces of mortar present on the surface of the lithotype near the sampling area; b) the presence of sodium, chlorine, copper, and sulfur may derive from an alteration of the material due to the presence of soluble salts deriving from an alteration of the artifact and/or from the exposure environment (presence of humidity, rising damp, etc.).

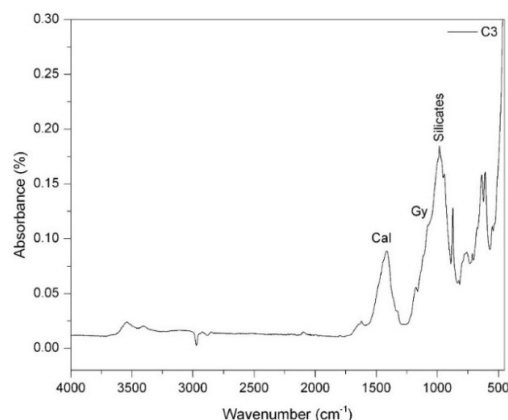
Infrared spectroscopy was essentially addressed at eventually identifying inorganic (i.e., mineralogical phases resulting from alteration processes) and organic (products resulting from any restoration work) compounds within the samples. All the analyses referred to samples ground by an agate mortar and pestle. A representative spectrum is reported in Figure 5. Specifically, the acquisitions allowed us to identify: a) the stretching vibrations of calcite, with characteristic peaks at ~ 1492 , 429 , 879 , and 706 cm^{-1} , and the presence of silicate compounds with intense absorption bands at $\sim 1000 \text{ cm}^{-1}$ attributed to Si-O vibrations, in all samples; b) the presence of gypsum, with characteristic peaks at about 3500 , 3400 , 1700 , 1600 , 1150 , 1100 , 700 and 600 cm^{-1} only in samples C3 and C6; c) the presence of hydromagnesite, with absorption bands at ~ 800 , 850 and 880 cm^{-1} and around ~ 1420 and 1480 cm^{-1} , only in samples C1 and C2; d) the presence of bands compatible with a siloxane polymer in C8.

Fig. 5. FT-IR spectra of sample C3.
