# Protecting Archaeological Collection: The Importance of Microclimatic Monitoring and preliminary diagnostic investigations in the Preservation of the “Sala delle Madri”

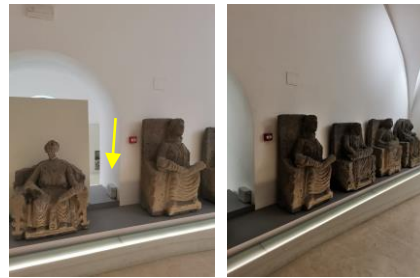
For the project, a smart object has designed and assembled for the non-invasive control of indoor environmental parameters of the site. Station is equipped with a microcontroller with custom firmware equipped with Bluetooth-Wi-Fi dual telecommunication channel and operating in Start-Go-Stop mode. The collected data are sent to a remote cloud and visualized through an application with a low-level analytics module. The monitoring station, shown in Figure 1, is equipped with a microcontroller, a multi-in-one air quality module integrating several sensors, including a laser dust sensor, an infrared carbon dioxide sensor, electrochemical sensors for formaldehyde, ozone, carbon monoxide, TVOC grade, and nitrogen dioxide, as well as temperature and humidity sensors. Additionally, electrochemical modules for hydrogen sulfide and sulphur dioxide monitoring are installed. A micro-fan inside the station is switched on for a pre-set time and frequency to have a balance with the environment to be monitored. Holes were made in the container to facilitate air exchange between the inside and outside of the station. During each sampling, the station acquired approximately 115 data points and provided four different types of values for each measuring point, including minimum, average, maximum, and the last acquisition. The monitoring station has several strengths. Firstly, it has small dimensions, which make it possible to install in areas where space is limited (Figure 1).

Fig. 1. Multiparametric station.

Secondly, it is highly customizable, allowing the addition or removal of sensors depending on the type of monitoring to be carried out. This makes the station versatile since it can be adapted to different contexts and environmental conditions. By customizing the sensors, it is also possible to detect pollutants that might otherwise go unnoticed, providing even more accurate and comprehensive measurements. The ability to change the configuration of the station also makes it an efficient and economical option, as it can be adapted to different sites and purposes.

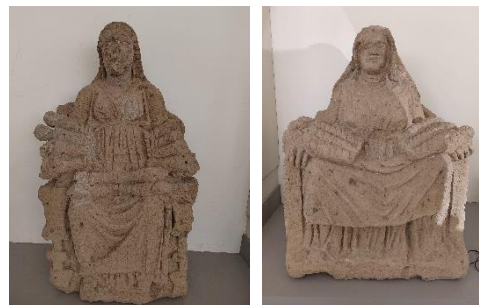
Non-invasive diagnostic investigations were performed on two votive statues in tuff selected for complexity of their surface due to the presence of restorations areas. Indeed, extended portions appear affected by a plaster that re-proposes the features of the faces and other details by altering the reading of the original surfaces. These restorations, considered historicized, have not been removed in order to document the conservation events of the collection over time. In the first step of ongoing study Visible fluorescence induced by Ultraviolet source (UVF) imaging was carried out on the votive statues depicting the "Madri" has been carried out to map the different materials constituting the surface of the sculptures. In particular, the two statues exhibited in room VIII, which were affected by incorrect past restorations (Figure 2).

Fig. 2. Two tuff statues involved in the preliminary diagnostic investigation.
