Integrated survey techniques for historical architectures: first results for Santa Maria della Croce in Casaranello, South of Italy

In this paper preliminary information of the research activity is reported, related to the thermographic investigation carried out on the front facade of the church object of investigation, through which the authors want to highlight possible traces of occlusions, openings, removal of materials that can clarify the original use of the monument.

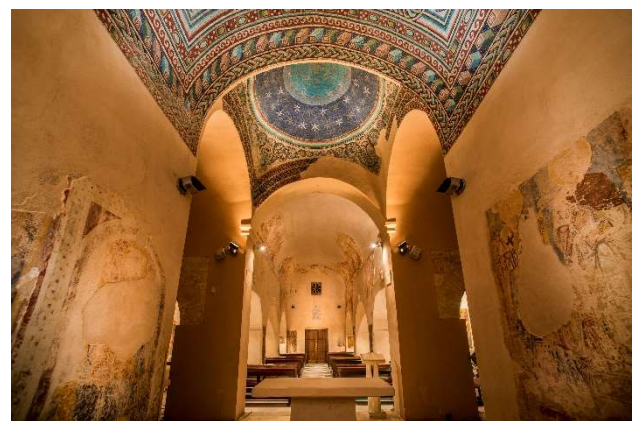
The church of Santa Maria Della Croce, known as the Casaranello Church, is one of the oldest monuments in Puglia, known for its interesting mosaic decorations and wall paintings inside. Early Christian mosaics, [27], dated to the 5th century, decorate the vault of the east arm and the dome of the cruciform choir, as shown in Fig. 1.

Fig. 1. Inside of the church of Santa Maria della Croce, Photos: Marco Santi Amantini.

In the hall of the Church, there are three naves with a barrel roof, communicating with each other by means of three large low arches resting on pillars with a square base that ends on two half pillars that insist on the counter and the choir.

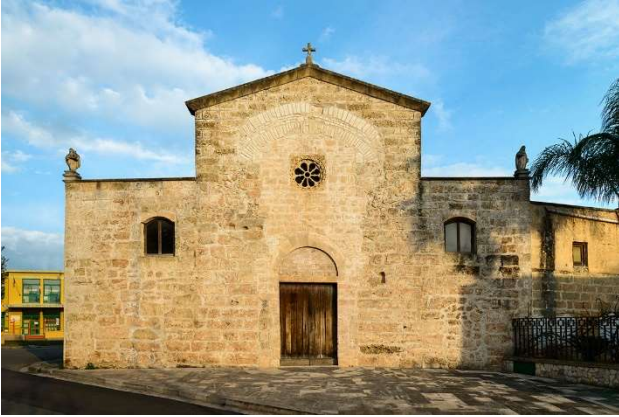
The entrance portal, the subject of the proposed investigation (fig. 2), is inserted in a portion of masonry that develops to reach the double arch of discharge; on this section of masonry is also inserted the rose window.

Fig. 2. Main facade of the church. Photos: Marco Santi Amantini

This masonry section is different from the one that completes the remaining part of the facade. As described by Spinosa, [5], which analyzes the entire architectural structure of the church, the wall band between the portal and the double arch is made of medium-sized limestone ashlar perfectly shaped and of constant size. The remaining part of the facade, instead, is made with large tuff ashlar of various sizes, placed in a regular manner up to the point where there are traces of two entrances now buffered (Fig. 3).

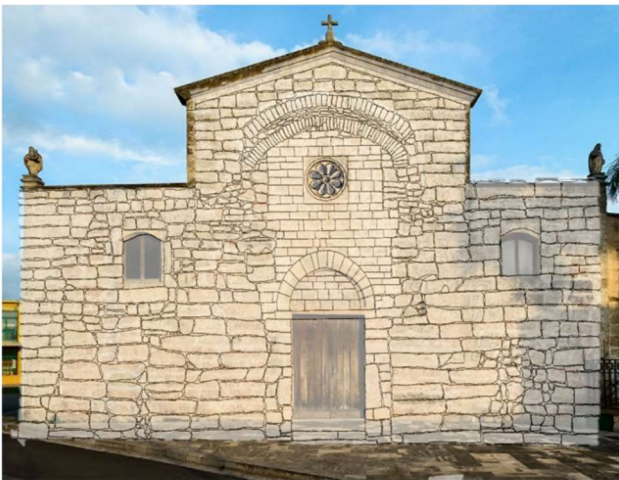
Fig. 3. Architectural relief of the main facade of the Church [5].

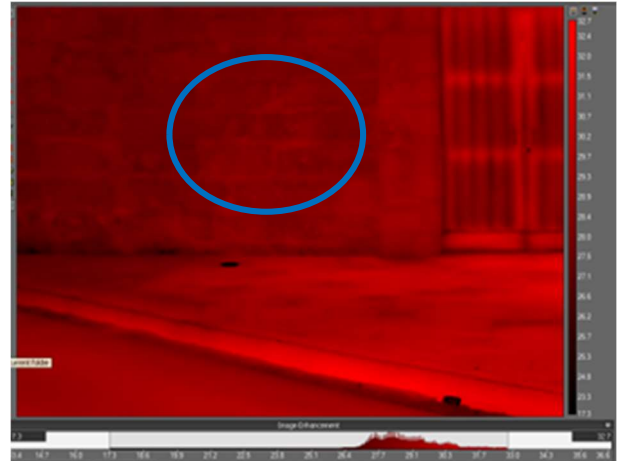
The recorded sequences have highlighted some details: looking at the facade, on the right side of the entrance portal, is clearly visible a small door now occluded, already evident from the architectural relief, visible in the thermographic image shown in Fig. 6. The area at the left side of the entrance (Fig. 7) highlights a hidden structure, not visible either from inside the church or from outside, and which could represent those structural elements highlighted in [3].

Fig. 7. Hidden structure at the left side of the church main entrance
