# Preventive conservation of the pictorial evidence in the church of Sotterra (Paola, Italy): a microclimatic investigation in a hypogeum environment

**Abstract** – The conservation of subterranean sites is an issue that poses hard questions, several of which are nowadays still unanswered. In the field of preventive conservation, microclimatic investigation is fundamental as it allows to examine the interaction between environmental conditions and degradation phenomena which occur on the artifacts. In the present study, a nine-months microclimate campaign was conducted inside the church of Sotterra in Paola, in the province of Cosenza (Calabria, Italy). The church, today located six metres under the ground level, represents a unicum since, despite its current location, it was originally built at ground level. The presbytery area preserves important mural paintings which date back from 11<sup>th</sup> to the 15<sup>th</sup> century which suffer severe damage due to extreme environmental conditions. The results already obtained from the diagnostic campaign of a previous work have been combined with the thermo-hygrometric values in order to assess the conservation risks of the pictor

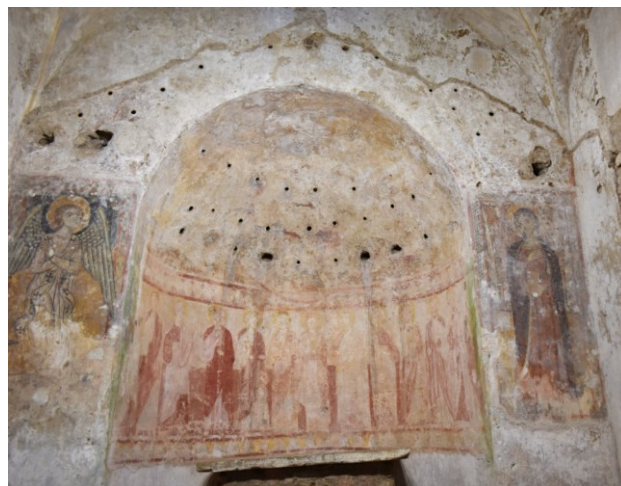
*Fig. 3. Wall painting in the apse of the church of Sotterra*

The main deterioration processes observed on the paintings surface are: salt crystallization, in the form of efflorescence and sub-efflorescence which have caused swelling of the plaster; lacunae of both the plaster and the pictorial film; biological colonization and calcareous encrustations.

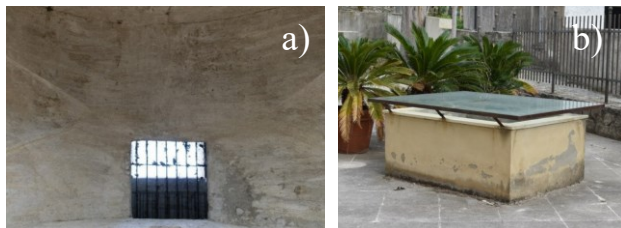
The environment is to be defined as confined but it is not totally isolated. In fact, above the presbytery area, in the vault of the first span, there is a hollow of a skylight, created by adapting the aperture made during the discovery of the building in order to come into the church. The latter, remodelled several times during the years, was the responsible for the phenomena of infiltration and rainwater which contributed, in the past, to the worsening of the already precarious state of

conservation of the pictorial evidence immediately below it. The aperture of the skylight is protected by a grating and a net that allows the keeping of any residues of various nature that could inadvertently fall inside the building (Figure 4a). Above it, at a higher level, the skylight was built. Although a glass plate is currently placed to protect the hollow, this is raised with respect to the masonry structure, allowing air exchange between the exterior and interior of the building (Figure 4b).

Fig. 4a. Skylight hollow viewed from the inside of the church; Fig. 4b. Skylight viewed from the outside of the church.

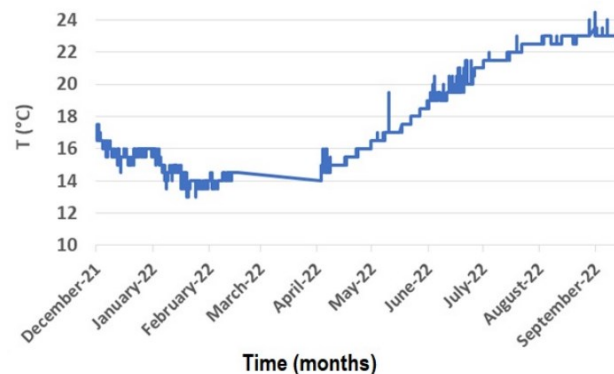
During the period under investigation, the indoor temperature range has a minimum of  $13^{\circ}\text{C}$  recorded in January and a maximum of  $24^{\circ}\text{C}$  measured in September (Figure 5). More generally, it is possible to state that the minimum temperatures are reached during January and February while the maximums are recorded during August and September.

Fig. 5. Temperature values measured inside the church for nine months from Zicarelli et al., 2023 [9].

The indoor temperatures show only gradual variations during the monitoring, with monthly averages fluctuations ranging between 1 and 3 degrees from month to month. In addition, the indoor climate is characterized by minimal daily variation that goes from 0 to 1 degree and rarely from 0 to 1.5 degrees. Only in an exceptional case, on May 15<sup>th</sup> 2022, the parameters of temperature show a significant increase of 2 degrees within 15 min, related to a massive frequentation of the site.

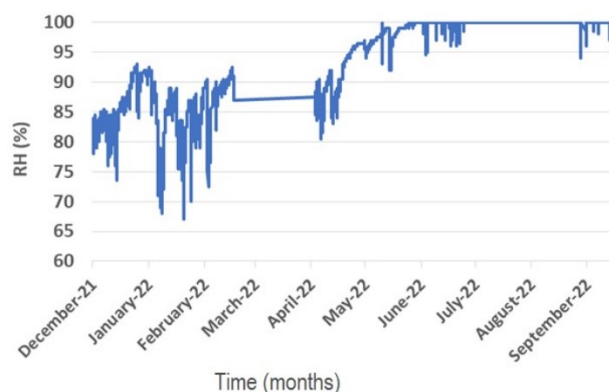
The microclimate of the church of Sotterra is characterized by high RH values, in line with those of the hypogea environments (Figure 6).

Fig. 6. Relative humidity values measured inside the church for nine months from Zicarelli et al., 2023 [9].

The average RH recorded indoor during the monitoring is 92%. The lowest value is acquired during winter, in

January (67%), while the condition of air saturation is reached in summer, starting from June. The results show wide daily oscillations of the RH values during winter, which sometimes reach 12% variation. During spring, the RH significantly increases, reaching 100% by June and maintaining the condition of air saturation until the first half of September.

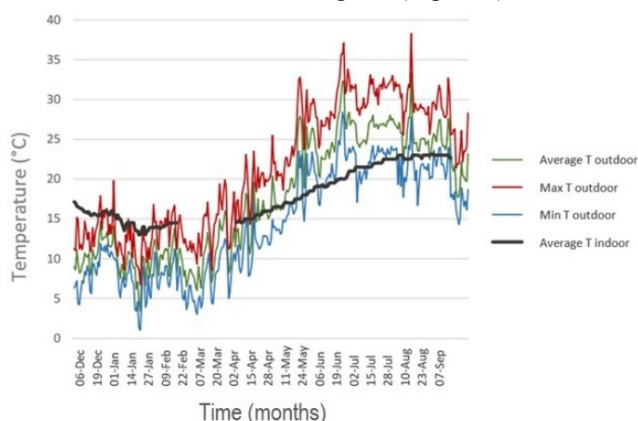
The indoor microclimate is characterized by a high thermal stability, even considering the external daily variations of more than 10 degrees (Figure 7).

Fig. 7. Temperature values measured in the church and the ones measured outside for nine months from Zicarelli et al., 2023 [9].

The minimum external temperatures are recorded from January to March, with a minimum of 0.9°C measured in January. The maximum outdoor temperature values are recorded during summer, from June to August, with maximum temperature values exceeding 38°C.

Due to the thermal inertia of the building, starting from May and during the summer, the indoor temperature values are lower than the external ones, while on the contrary, in winter the internal temperatures are higher than the ones acquired outdoors.

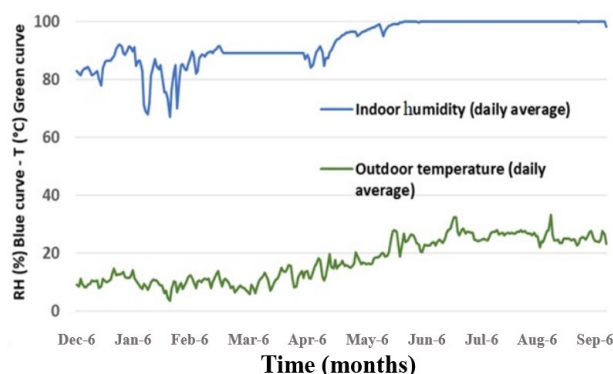
It is not possible to establish the relationship between the RH values recorded within the church and the external ones due to a lack of data relating to 2021 and 2022 in the ARPACAL archive. Nevertheless, a correlation between the indoor RH and the outdoor T is evident (Figure 8).

Trends of microclimatic data show that at the beginning of the summer period, the RH inside the church increases as the outside temperature increases.

Fig. 8. Daily average humidity (indoor) and daily average temperature (outdoor) for nine months from Zicarelli et al., 2023 [9].

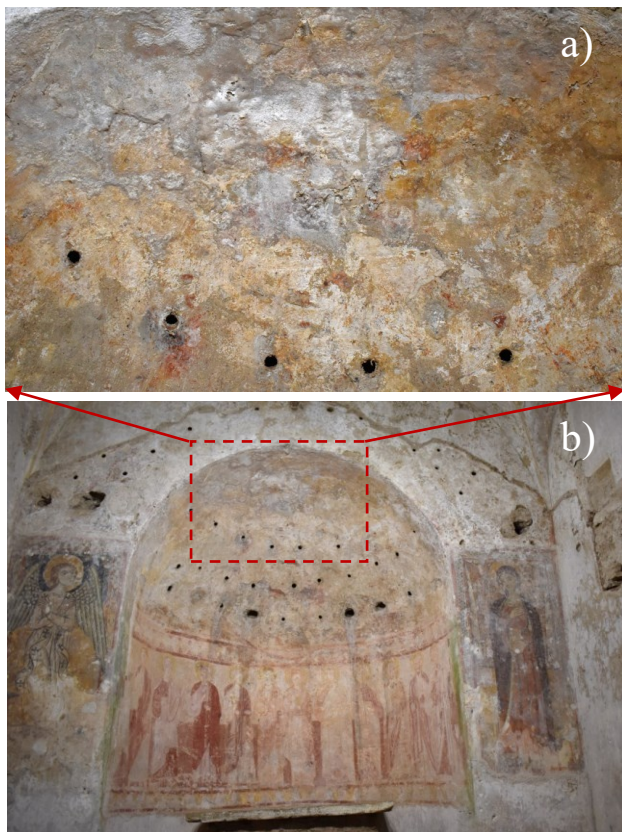
With regard to the microclimatic data, from a theoretical point of view, precipitation of calcium sulphate occurs starting from the second half of September, when the RH values are lower than 100%. This statement is supported by in situ observations. In fact, from the autumn to spring season, the wall paintings inside the presbytery area are affected by the crystallization phenomenon, in the form both of efflorescence and sub-efflorescence (Figure 9b). The effects of crystallization are particularly visible on the semi-dome area, which is involved in significant swelling

processes of the plaster that have caused the loss of the pictorial film (Figure 9a). It can be assumed that this phenomenon is largely related to the air flows coming from the outside and conveyed inside by the skylight placed immediately above, in correspondence with the painting. These likely cause a more rapid evaporation of the aqueous solution inside the wall, leading to the formation of sub-efflorescence.

Fig. 9a. Sub-efflorescence and swelling of the plaster in the semi-dome. Fig.9b. Picture of the presbytery area taken on October 14<sup>th</sup>, 2021.

Based on the observation conducted inside the church, the cycles of crystallization and dissolution produced by wetting/drying cycles and oscillations of RH values, occur annually, representing a conservative risk that must be considered. To ensure the preservation of the pictorial evidence and to minimize the decay produced by crystallization phenomenon, theoretically, it is necessary to maintain the RH values permanently above or below the  $RH_{eq}$  of the salt phase in the system [4]. Considering that high parameters of RH might cause dissolution processes and microorganism growth, it is possible to conclude that safe microclimatic conditions to avoid salt crystallization have to be set below the  $RH_{eq}$  values of calcium sulphate (~99%). This means that wetting/drying cycles that affect the wall inside the church must be limited.

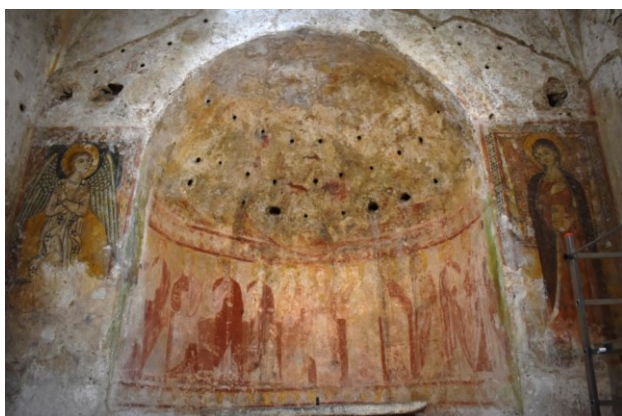
Fig. 10. Picture of the presbytery area taken on July 7<sup>th</sup>, 2022.

Otherwise, starting from June, RH values reached the 100%, giving as a result the deliquescence of the salt (Figure 10).
