Diagnostic investigation on a Sorel and Portland cement boiserie at Palazzo Fizzarotti (1850-1908, Bari)

Abstract – This paper reports the results of the diagnostic investigation conducted on the boiserie of the Rococo Hall at Palazzo Fizzarotti (1850-1908) in Bari. The boiserie is an artifact made of faux marble with included *seminato* elements (*marmette*) and characterized by the presence of assembly plastering. The study aimed to identify its constituent materials, reconstruct the production technique, and understand its conservation state to carry out a critical restoration work which respected the boiserie from a material, historical and aesthetic point of view.

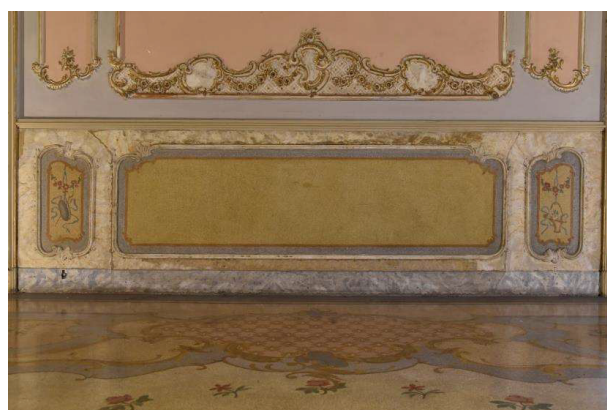
Fig. 1. The panel of the boiserie of the Rococo Hall at Palazzo Fizzarotti.

The artifact here investigated is one of the six elements of the boiserie of the *Salone Rococò* in Palazzo Fizzarotti (Fig. 1). Interrupted by five doors and one window, it lines the lower part of the wall along the entire perimeter of the hall and forms a connecting element between the walls of the hall, richly decorated with stucco, gilding and mirrors, and the *terrazzo alla veneziana* floor.

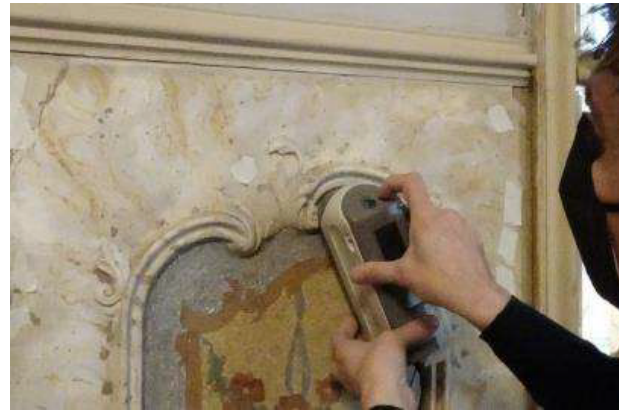
Fig. 3. Execution of a spectrophotometric analysis on the right panel of the boiserie.

Non-invasive analysis took place in situ (colorimetry, pXRF, UVF). The colorimetric measurements were performed using a portable spectrophotometer Konica-Minolta CM-2600d equipped with standard illumination using a Xe lamp (Fig. 3). An overview of the colors measured in the boiserie is shown in Fig. 4.

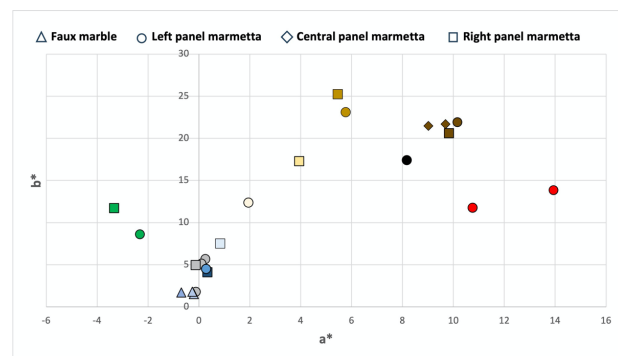
Fig. 4. Mean values of the color coordinates of the boiserie. The color of the symbols approximates the observed color.

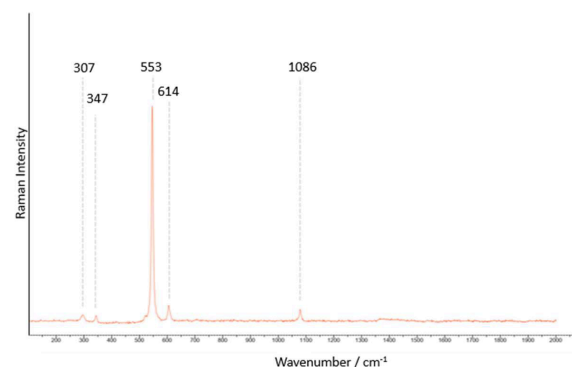
Fig. 9. PFP_R1: Raman spectrum of chromium oxide green.

μRaman was very useful to identify pigments used. In both the decorative elements of the floor and the faux marble, particularly in correspondence of the blue color, chromium oxide green (CrO₃) was identified due to the presence of the peaks at 307, 347, 553, 614 cm⁻¹ (Fig. 9) and confirmed by pXRF. The blue pigment is ultramarine, whereas red and black are hematite and C black, respectively.
