Decay assessment approach of building stones from cultural heritage in freshwater reservoirs

Ada Sáez*¹, Natalia Pérez-Ema¹, Mónica Álvarez de Buergo¹

town of The Royal Site of La Isabela, located in the Buendía reservoir in the province of Guadalajara.

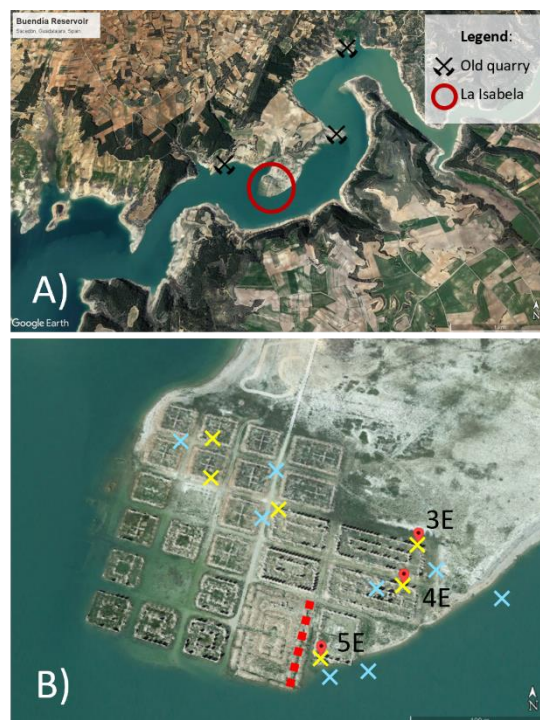
The case of La Isabela is not a single building but an entire submerged village, therefore, three walls have been selected to represent different conditions occurring at this site (Fig. 2. B). The proximity to the interior of the reservoir and the terrain's inclination has been considered, since some walls spend more time submerged than others, as well as the orientation of the façades. Thus, the North and South façades of three walls that are at different distances from the shore are being studied (walls named 3E, 4E, and 5E in Fig. 2. B). Wall nomenclature is based on their location on the map of the old town shown in Fig 2. B. The town streets form a grid layout of numbered rows (1 to 6) and lettered columns (A to E) corresponding to each block of the buildings' ruins. The selected walls, 3E, 4E, and 5E, were chosen because they are in the most accessible part of the town and share similar terrain elevations. In each wall, the different properties are measured at various heights.

Fig. 2. A) General view from Buendía reservoir. B) Closer view of La Isabela. The red dotted line marks the palace's NE façade as in Fig. 1. Red pins indicate the studied walls 3E, 4E, and 5E. Crosses mark the sampling points, yellow for solid and blue for water samples. Each point may represent several samples in the same location.
